MISSOULA URBAN DRAINAGE
INTERSTATE HIGHWAY

PROJECT 1-90-2(27)103 UNIT 1

INVESTIGATION REPORT
MISSOULA URBAN DRAINAGE
NEAR
MISSOULA, MONTANA

Prepared By
MORRISON-MAIERLE, INC.
Consulting Engineers
Helena, Montana

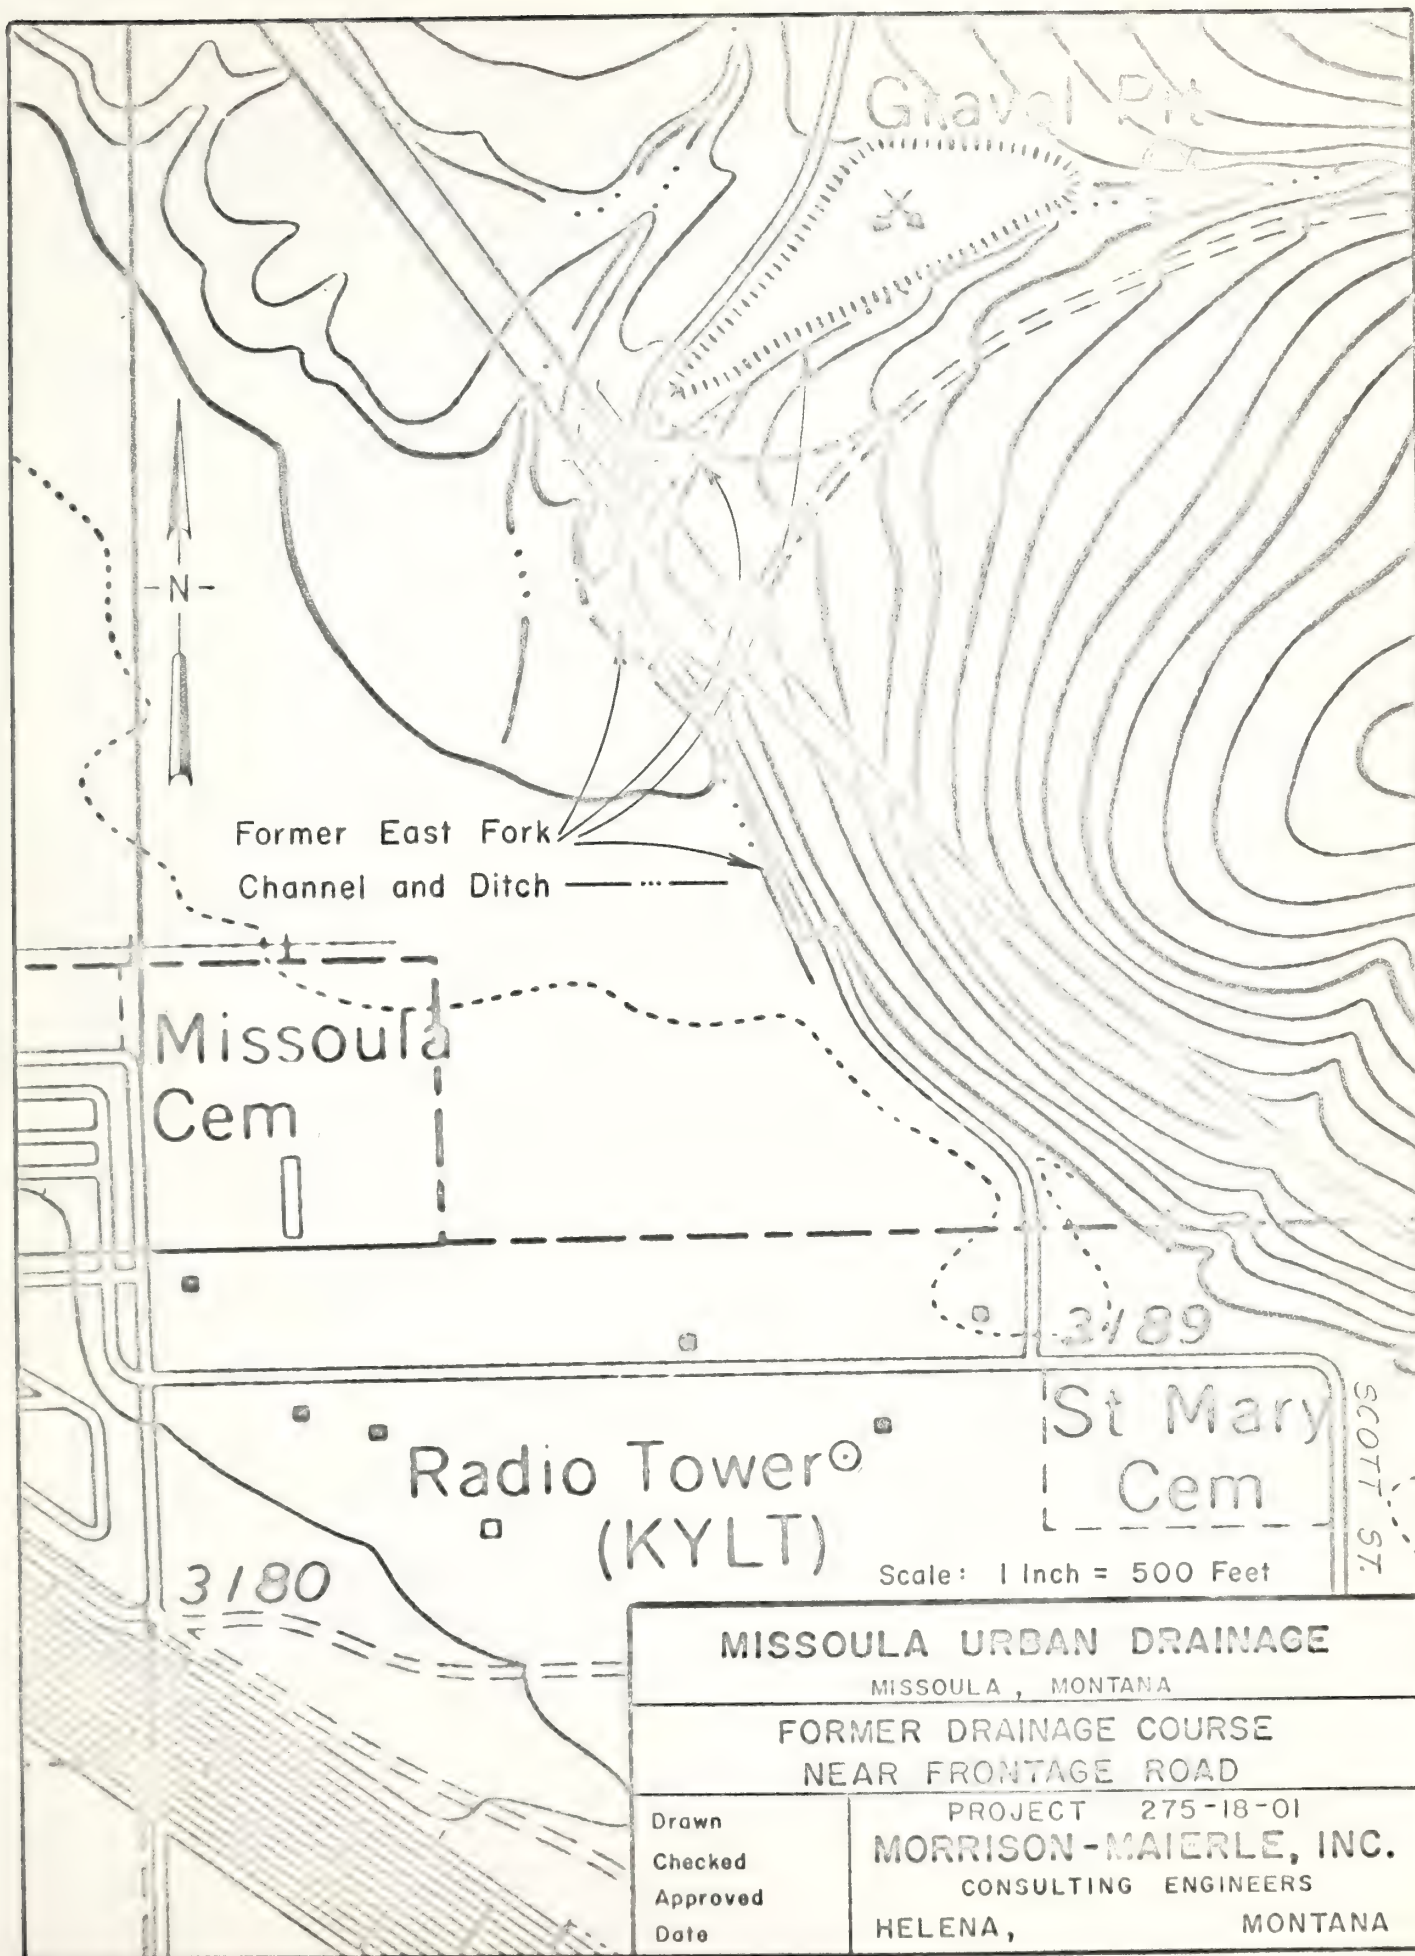
Photographs and maps prepared prior to Interstate Highway construction show East Carlson Gulch water crossed the old county road in a culvert and followed the westerly side of the county road for more than 1,000 feet. FIGURE 3 is an enlargement of a part of the U.S. Geological Survey quadrangle map completed in 1964. The map illustrates this channel and may clarify the previous discussion of Area A. The Interstate Highway and Frontage Roads A₁ and A₂ have been superimposed on this illustration. Cross section surveys and maps prepared for Interstate construction also define the channel with respect to the old county road. The farm road which served the inhabitants of East Carlson Gulch followed a minor drainage course for about 500 feet and also intercepted sidehill drainage east of the farm road. The drainage area served by this water course was about 55 acres. The flow either passed over or under the county road to the ditch on the west side. A pile of bark and debris provided an obstacle to overflow of the ditch at the northeast corner of the Van-Evan log yard. The ditch was somewhat obstructed or obliterated

by logs and grading of earth or debris although the moving water would apparently have to flow toward the ponding area near Shakespeare Street. Mr. Carlson, an old resident, pointed out the remains of an old rock wall about 200 feet north of Otis Street. This wall helped contain flood waters of the ponding area on a number of occasions.

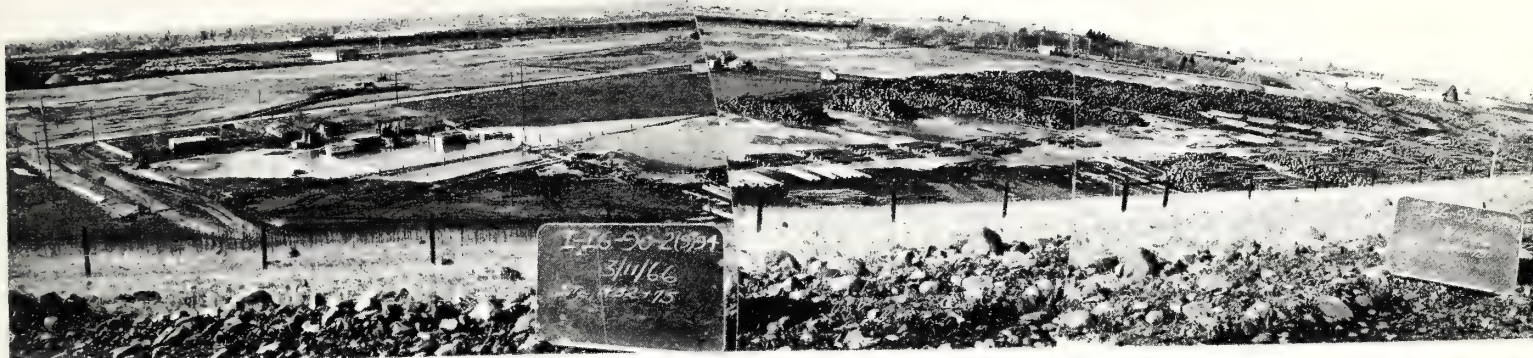
4A- PANORAMIC VIEW OF MARCH 11, 1966

Inquiry of old residents points to more frequent flooding due to snow melt than to rain. The snow-melt flooding of March 9-11, 1966 provides some data for study of an event following Interstate construction. The panoramic photographs of FIGURE 4 present a view of the problem area on March 11, 1966 as well as on June 14, 1967. Temperatures at Missoula were substantially above normal and precipitation was slightly above normal for the period November 1965 through February 1966. A tabulation of weather data at the Missoula airport and at Missoula 2 NW (Sugar Factory) are given in the table that follows:

Photographs taken on March 11 show small patches of snow on slopes facing other than south below about 3400 foot elevation. South slopes were bare of snow beyond the 3400 foot level. Complete snow cover is apparent in the higher levels of the Carlson Gulch area. Nearly all the snow was gone from about 100 acres of the East Fork of Carlson Gulch drainage and on about 90 acres of the West Fork of Carlson Gulch. From an empirical formula of snow melt with respect to temperatures above 32° F., the melt of about 1½ to 2 inches water seems reasonable for much of the bared area. Partial melt is apparent to an elevation of about 3600 feet. Very little runoff was likely above the 3600 foot level as the snow would have absorbed some and the ground would probably not have been frozen. Conversion of the assumed melt to runoff would result in approximate value of about 20 acre-feet for the drainage area of East Carlson Gulch, the sidehill and the Interstate roadway drainage that would have reached the northeast approach road to the Van-Evan log yard.

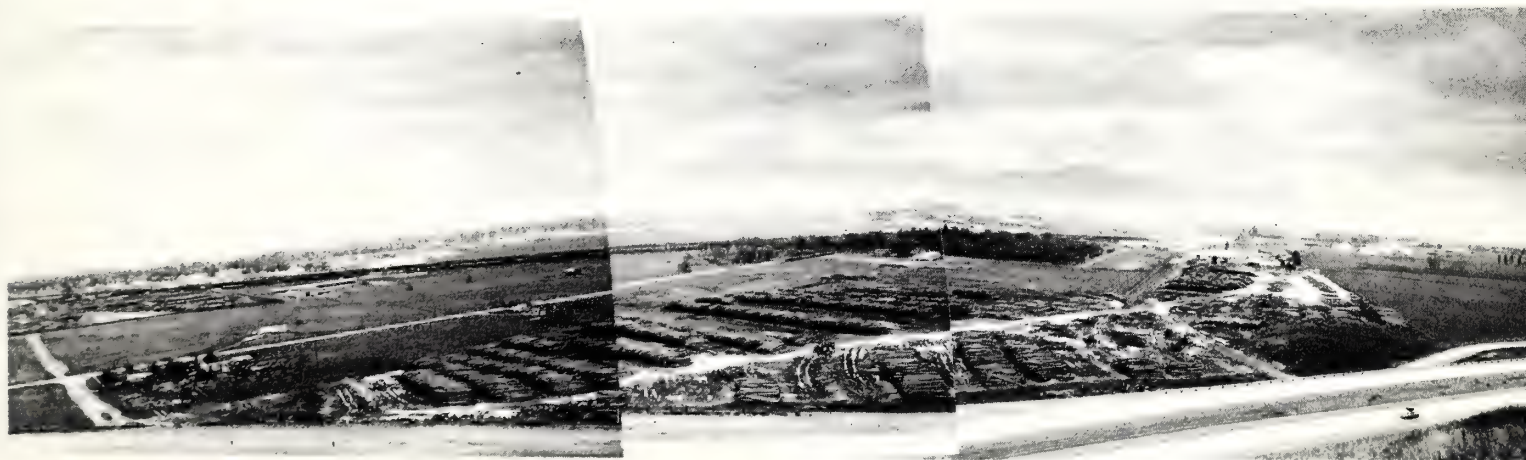
4B - PANORAMIC VIEW OF JUNE 14, 1967

Rain alone has apparently been responsible for few floods although it can result in rather frequent interference with an operation such as the handling of logs at the Van-Evan yard. Observations of May 1-3, 1967 and June 14, 1967 show a distinct problem of poor drainage and ponding in that area. The first period included the last two days of a rainy period of a week. The total rain was 1.06 inches at the Missoula Airport. On the morning of May 2, there was evidence of night time flow from the Interstate median drain just east of the underpass. There had also been a little water in the 24 inch culvert about 400 feet east. A little water from these sources had flowed into the Van-Evan log yard. Much of the log yard was covered with a soupy clay mud.

Recorded precipitation from May 31 to June 13, 1967, was 3.01 inches. Daily amounts varied from a trace to 0.41 inch, with 0.36 inch on June 13. On June 14, there was evidence of recent peak flow of about 0.3 cfs in the Interstate median drain on the east side of the underpass and about 0.5 cfs in the 24 inch culvert about 400 feet eastward. The peak flow of the median drain west of the underpass was probably not as much as 0.2 cfs. There had been a little wetting of the upper end of the 48 inch culvert through the Interstate due to East Carlson Gulch. The water level in the pond on Carlson Gulch was 0.45 feet higher than on May 2. Recent water marks were about 0.5 foot higher than the June 14 level observed. This would indicate the temporary storage of about 0.25 acre feet. The drop of 0.5 foot confirms reports of Mr. Carlson that there is fairly rapid seepage from the pond above a fairly fixed low-water level.
